DEPARTMENT OF TRANSPORTATION**DIVISION OF ENGINEERING SERVICES**

Contract #: 04-0120F4Cty: SF/ALA Rte: 80 PM: 13.2/13.9File #: 69.28**WELDING INSPECTION REPORT****Resident Engineer:**Pursell, Gary**Address:** 333 Burma Road**City:** Oakland, CA 94607**Report No:** WIR-000567**Date Inspected:** 01-Oct-2007**Project Name:** SAS Superstructure**OSM Arrival Time:** 630**Prime Contractor:** American Bridge/Fluor Enterprises, a JV**OSM Departure Time:** 1530**Contractor:** Zhenhua Port Machinery Company, Ltd (ZPMC), Changxing Island **Location:** Shanghai, China

Bridge No: 34-0006**Component:** Tower Mock-up 77 and 114 M**Summary of Items Observed:**

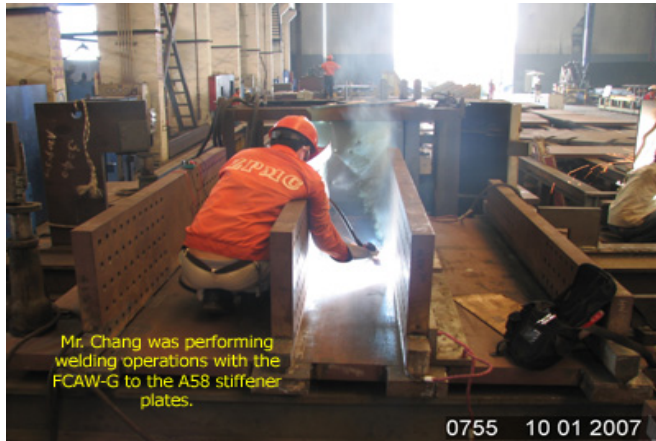
Item	Description	WBS	Dwg No.	Status
1	Splice panel to longitudinal stiffeners welding ZPMC, welder Chang Chuancang was observed by the QA Inspector performing welding operations on the splice panel A58 panel weld joint # 2 (p268 longitudinal stiffener). Mr. Chang was following the approved welding procedure specification WPS-B-T-2332-TC-U5-F. Base metal was designated as A-709 Grade 50. ZPMC was using the flux cored arc welding (FCAW) process in the horizontal (2G) position with the 1.4 mm diameter electrode designated as E71T-1 /AWS A5.20, brand name Supercored. The QA Inspector verified amperage, voltage, travel speed, preheat and heat interpass temperatures for the filler passes. The

QA inspector found that the welding parameters recorded after ZPMC approved Certified Welder Inspector Xu Bing appeared to be in accordance with the contract documents.
